**Location:** D-64546 Mörfelden-Walldorf  
**Architects:** Schauer + Volhard, Darmstadt  
**Construction:** 9/1997-4/1999

## Two half-timbered houses, Mörfelden

## earthen building · case study

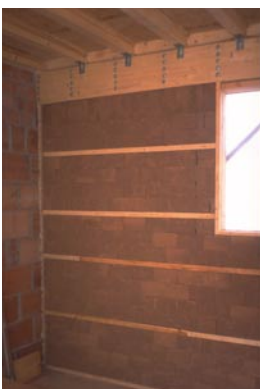
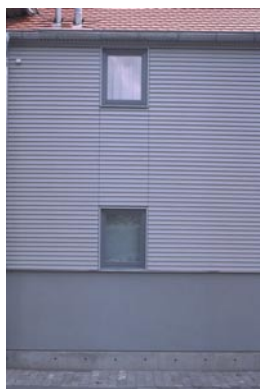
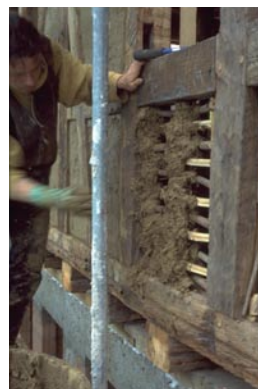
Repairing earthen infill panels Haus Schneiker

paints. The infill panels of the half-timbered sections were carefully restored with a wattle and daub construction. As with traditional techniques, the undercoat was grooved to provide a key for the facing coat of lime render.
